From: "Davis, Mike" <MDavis@archcoal.com>
To: "Chris Hansen (E-mail)" <CHansen@archcoal.com>, "Craig Hilton (E-mail)" <CHilton@archcoal.com>, "Daron Haddock (E-mail)" <daronhaddock@utah.gov>, "Dave Darby (E-mail)" <davedarby@utah.gov>, "Erik Petersen (E-mail)" <petersen@relia.net>, "Jerriann Ernstsens (E-mail)" <jerriannernstsens@utah.gov>, "Ken May (E-mail)" <KMay@archcoal.com>, "Mark Bunnell (E-mail)" <MBunnell@archcoal.com>, "Pam Grubaugh-Littig (E-mail)" <Pamgrubaughlittig@utah.gov>, "Pete Hess (E-mail)" <petehess@utah.gov>, "Steve Fluke (E-mail)" <stevefluke@utah.gov>, "Susan White (E-mail)" <susanwhite@utah.gov>
Date: 12/08/2003 3:11:24 PM
Subject: East Fork Box Canyon Monitoring 12/1&3/03

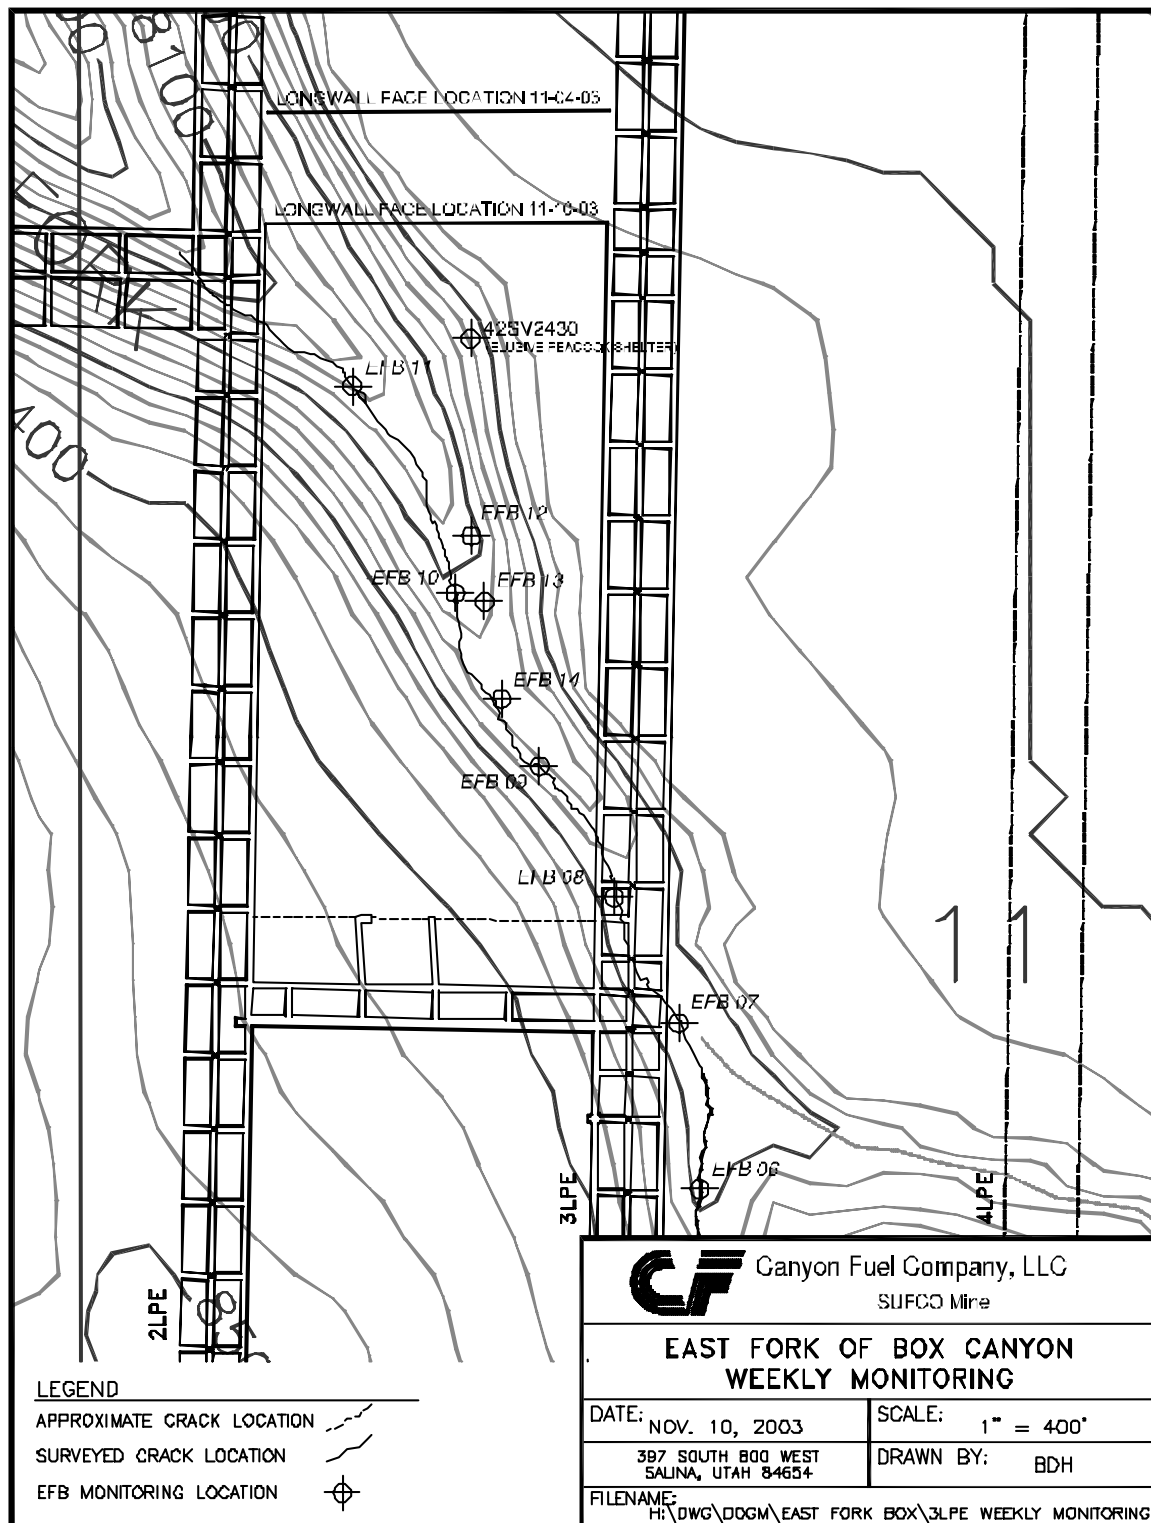
During the 12/01/03 inspection the shelter looked about the same. No visual evidence that the floor of the upper shelter had collapsed. The stream channel fracture zone found on 11/26/03 located approximately 100 feet below EFB-11 had an approximately 30 foot reach of the stream channel dry. Flow was reestablished in the 30 foot reach by plugging a few small holes in the stream bottom with native stream sediments.

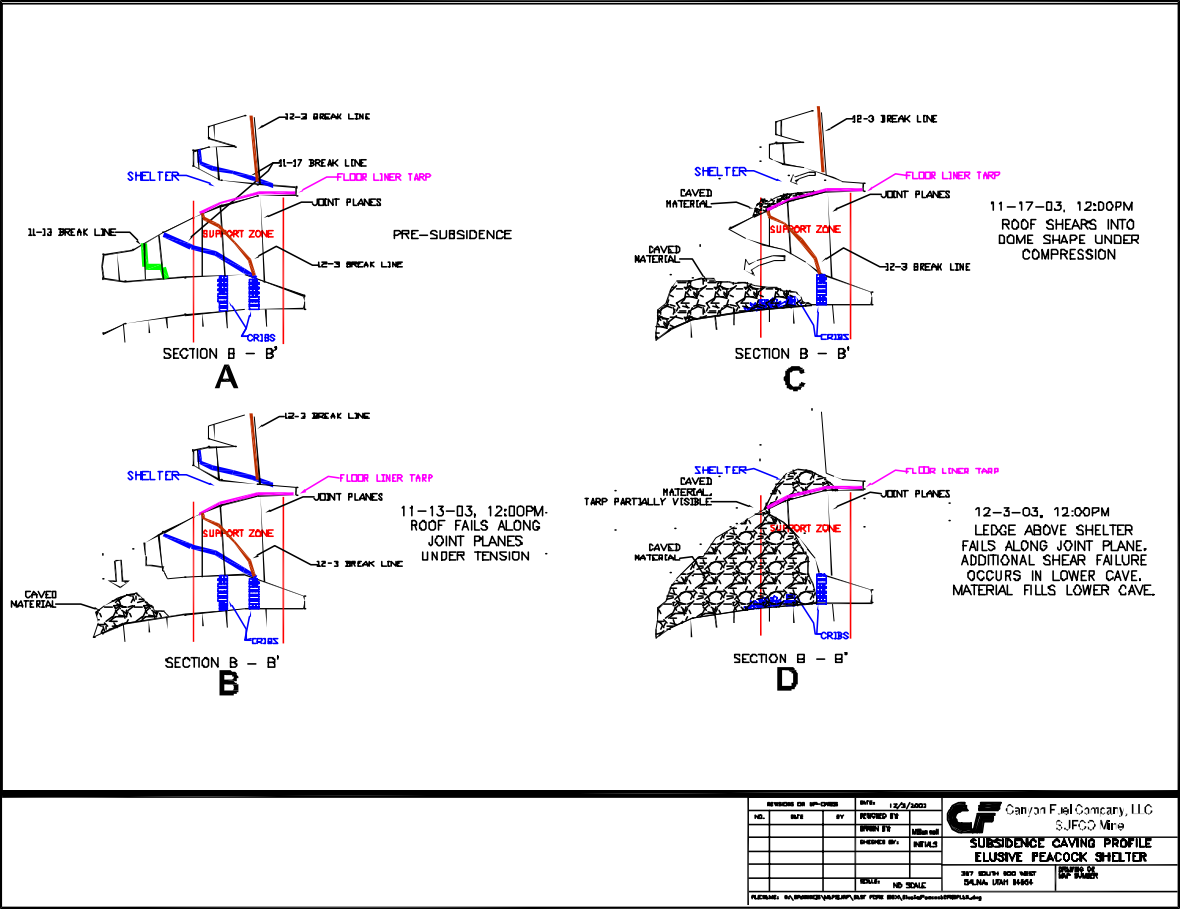
During the 12/03/03 inspection the shelter looked about the same. There is still no visual evidence that the floor of the upper shelter has collapsed. The sandstone beds in the stream channel bottom were observed to have fractured and have buckled up in another location at approximately 200-250 feet below EFB-11. The flow is being temporarily disrupted by flowing beneath the buckled zone and reappears about 30 feet below the site.
